RUD Chain Fitment at Lumwana Mine, Zambia

Aust-Africa recently participated in a RUD chain fitment at Lumwana mine in Zambia's Copperbelt.

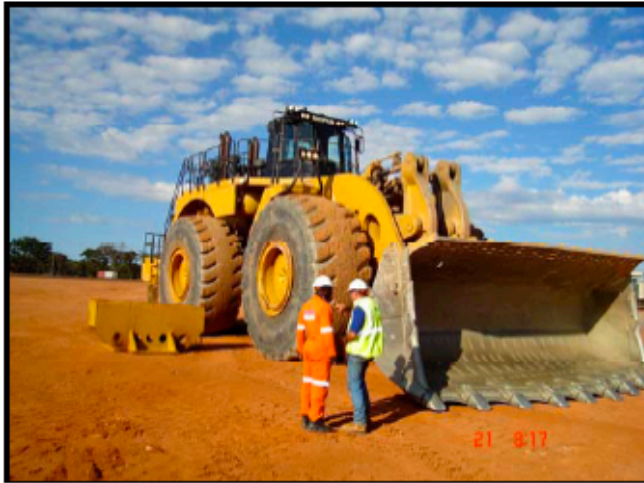
Fig 1. CAT 944F to be fitted with chains. Needed to have a front tyre replaced before fitting chains

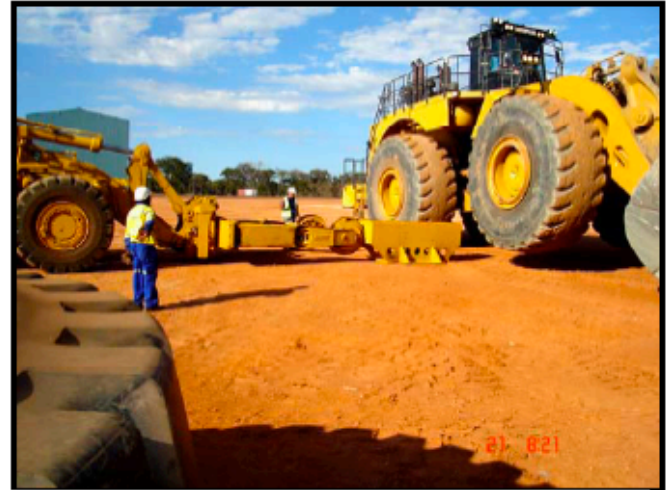
Fig 2. Jacking up the CAT 944F

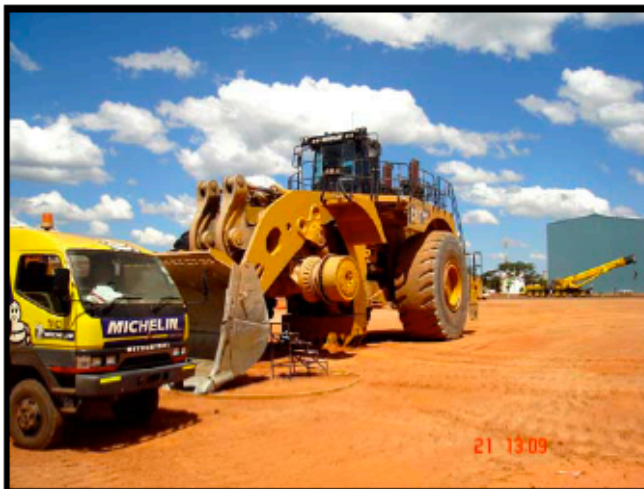
Fig 3. Ready to have new tyre fitted

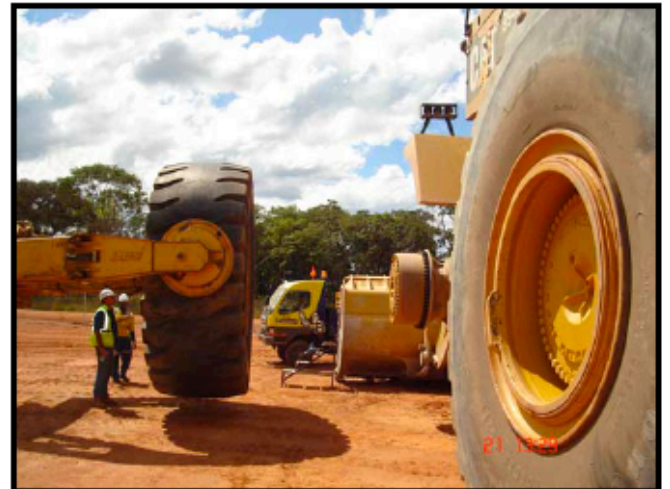
Fig 4. Tyre handling machine lining up to fit new tyre onto hub

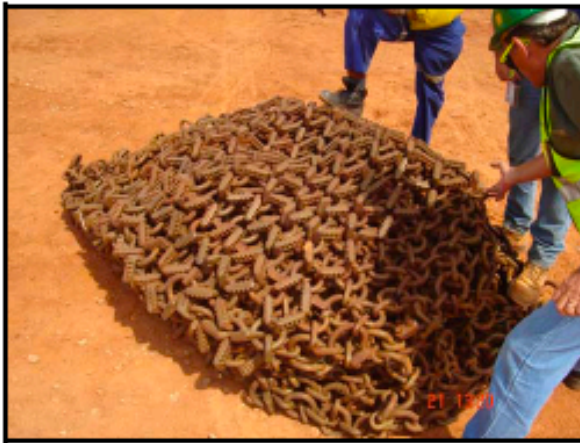
Fig 5. Folded chain

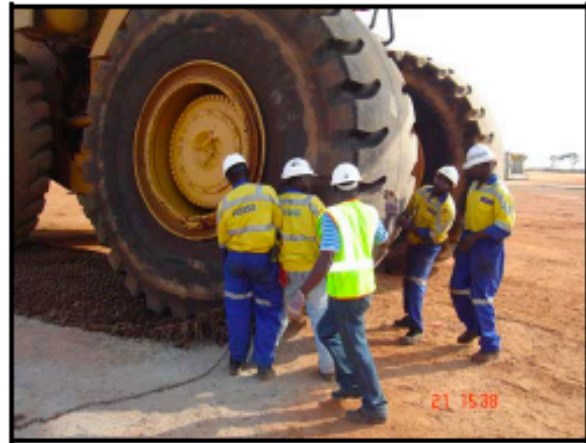
Fig 6. Hooking the chain onto the lug

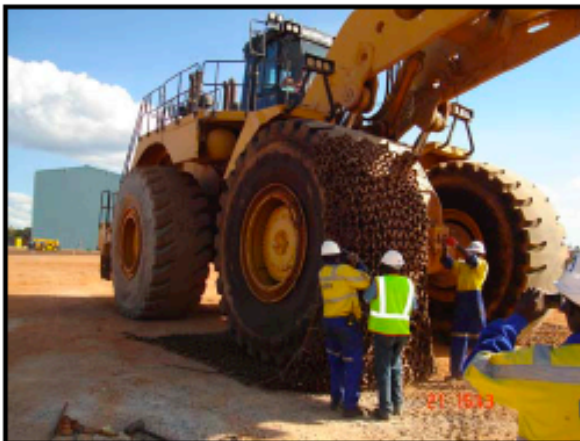
Fig 7. Positioning the chain while reversing

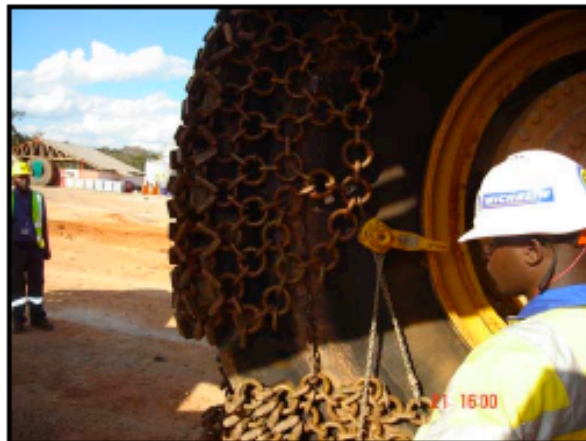
Fig 8. Using tic-toc to stretch the chain to join ends

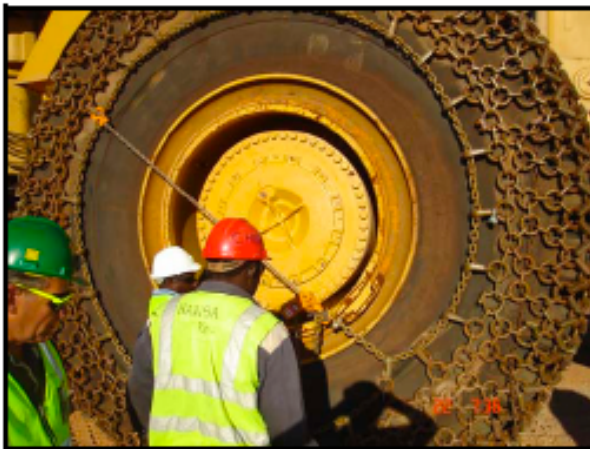
Fig 9. Chain tensioning

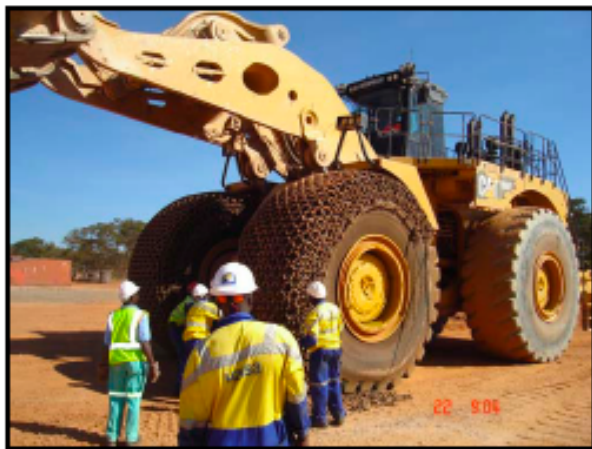
Fig 10. Fitting of 2nd chain
